**Flood Control Project Maintenance
Levee Inspections****LMA District Cover Sheet****Spring 2015 Levee Inspection Results****Sutter Maintenance Yard Tisdale Bypass**

Spring 2015 Levee Inspection Results

Sutter Maintenance Yard Tisdale Bypass

Levee Inspection Report By Mile - Spring 2015

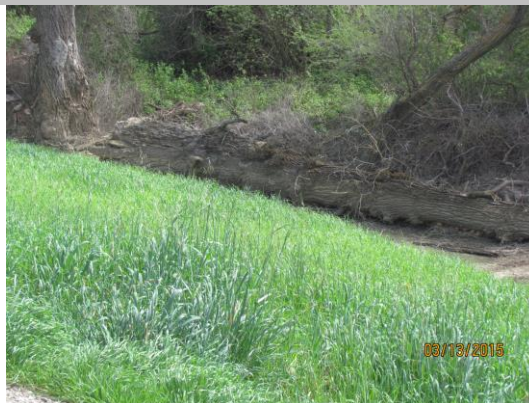
Photo 1 of 1 : SP_2015_ST0009_286_6_20150406_00002.jpg

LM Start	1.50	Rating **	M	Issue No.	6
LM End	1.50	Issue Type +	En	Location *	WS
Category	Earthen Levee			GPS Latitude/Longitude	
				Start	End
Item	Encroachments			39.028268 °	39.028268 °
				-121.794308 °	-121.794308 °
DWR ID	DWR_ST0009_01_s_2015_6				
Action/Comments					
Tree or limb					
Inspector Comments: Remove the tree from the waterside toe.

View of the tree that is along the waterside toe.

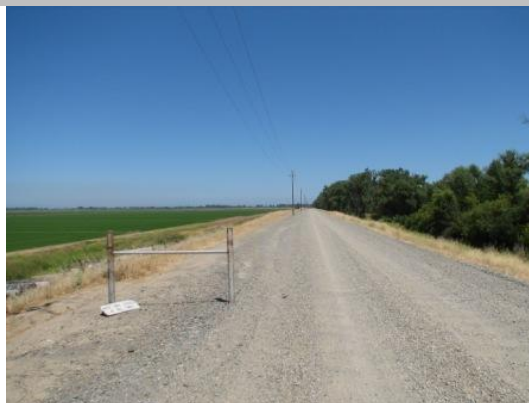
Photo 1 of 1 : SP_2015_ST0009_286_3_20150310_00001.jpg

LM Start	2.19	Rating **	M	Issue No.	3
LM End	4.11	Issue Type +	En	Location *	LS
Category	Earthen Levee			GPS Latitude/Longitude	
				Start	End
Item	Encroachments			39.028173 °	39.028012 °
				-121.781475 °	-121.745665 °
DWR ID	DWR_ST0009_01_s_2012_3				
Action/Comments					
Pole

View of the PG&E poles along the landside crown of the levee.

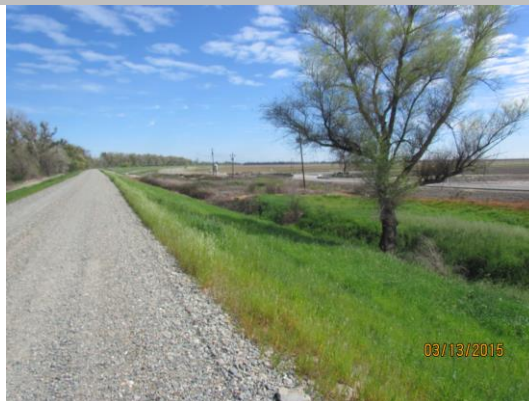
Photo 1 of 1 : SP_2015_ST0009_287_1_20150406_00408.jpg

LM Start	0.11	Rating **	M	Issue No.	1
LM End	0.26	Issue Type +	En	Location *	LS
Category	Earthen Levee			GPS Latitude/Longitude	
				Start	End
Item	Encroachments			39.023760 °	39.024559 °
				-121.818875 °	-121.816344 °
DWR ID	DWR_ST0009_02_s _ 2012_1				
Action/Comments					
Ditch					
Inspector Comments: Monitor the ditch for erosion.

View of the agricultural ditch along the landside toe.

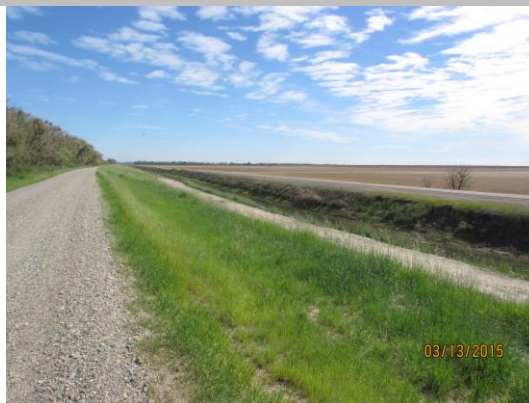
Photo 1 of 1 : SP_2015_ST0009_287_2_20150406_00409.jpg

LM Start	0.52	Rating **	M	Issue No.	2
LM End	1.74	Issue Type +	En	Location *	LS
Category	Earthen Levee			GPS Latitude/Longitude	
				Start	End
Item	Encroachments			39.025539 °	39.025398 °
				-121.811540 °	-121.789006 °
DWR ID	DWR_ST0009_02_s _ 2012_2				
Action/Comments					
Ditch					
Inspector Comments: Monitor the ditch for erosion.

View of the agriculture ditch next to the landside toe.

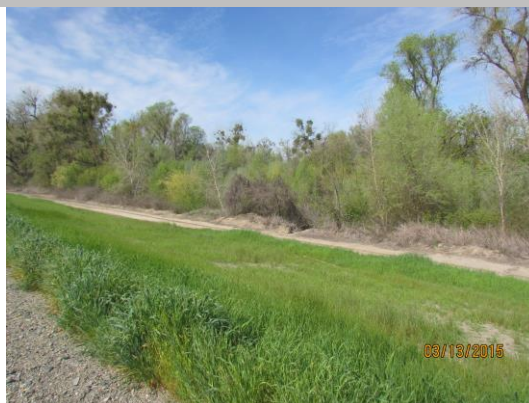
Photo 1 of 1 : SP_2015_ST0009_287_3_20150406_00410.jpg

LM Start	1.01	Rating **	M	Issue No.	3
LM End	1.01	Issue Type +	Ma	Location *	WS
Category	Earthen Levee			GPS Latitude/Longitude	
				Start	End
Item	Erosion / Bank Caving			39.025542 °	39.025542 °
				-121.802468 °	-121.802468 °
DWR ID	DWR_ST0009_02_s _ 2012_3				
Action/Comments					
Note and monitor erosion site.					
Inspector Comments: Sutter Yard needs to monitor the erosion.

View of the erosion along the waterside berm.

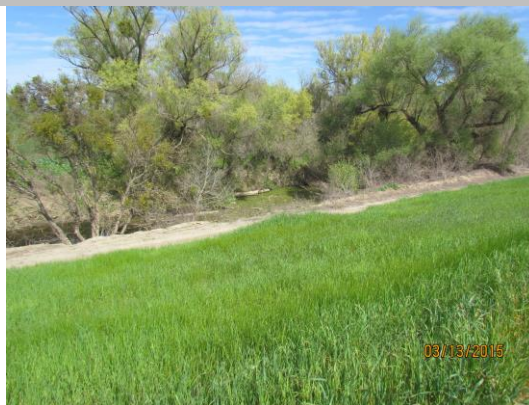
Photo 1 of 1 : SP_2015_ST0009_287_290_20150406_00411.jpg

LM Start	1.19	Rating **	M	Issue No.	290
LM End	1.19	Issue Type +	Ma	Location *	WS
Category	Earthen Levee			GPS Latitude/Longitude	
				Start	End
Item	Erosion / Bank Caving			39.025490 °	39.025490 °
				-121.799240 °	-121.799240 °
DWR ID	DWR_ST0009_02_s _ 2015_290				
Action/Comments					
Note and monitor erosion site. Inspector Comments: Sutter Yard needs to monitor the erosion along the berm.

View of the erosion along the waterside berm.

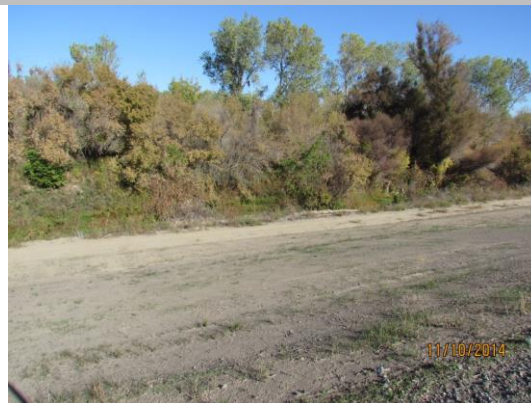
Photo 1 of 1 : SP_2015_ST0009_287_4_20150310_00004.jpg

LM Start	1.29	Rating **	M	Issue No.	4
LM End	1.29	Issue Type +	Ma	Location *	WS
Category	Earthen Levee			GPS Latitude/Longitude	
				Start	End
Item	Erosion / Bank Caving			39.025478 °	39.025478 °
				-121.797232 °	-121.797232 °
DWR ID	DWR_ST0009_02_s_2013_4				
Action/Comments					
Schedule repair of erosion site prior to the next inspection.					
Inspector Comments: Sutter Yard needs to monitor the erosion.

View of the erosion along the waterside berm.

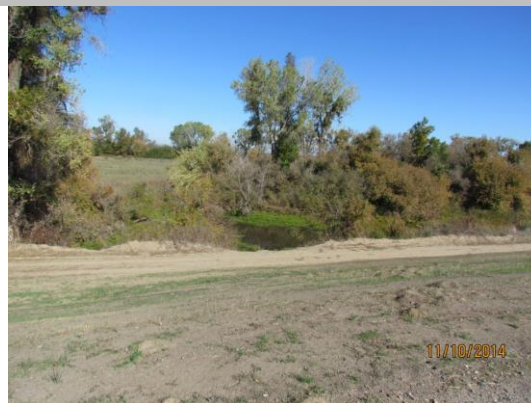
Photo 1 of 1 : SP_2015_ST0009_287_5_20150310_00005.jpg

LM Start	1.50	Rating **	M	Issue No.	5
LM End	1.50	Issue Type +	Ma	Location *	WS
Category	Earthen Levee			GPS Latitude/Longitude	
				Start	End
Item	Erosion / Bank Caving			39.025446 °	39.025446 °
				-121.793347 °	-121.793347 °
DWR ID	DWR_ST0009_02_s_2013_5				
Action/Comments					
Schedule repair of erosion site prior to the next inspection.					
Inspector Comments: Sutter Yard needs to monitor the erosion.

View of the erosion along the waterside berm.
